**SOUTHWEST CITY STRUCTURE
McDONALD COUNTY, MISSOURI
MO 20510**

PHASE 1 INSPECTION REPORT NATIONAL DAM SAFETY PROGRAM

PREPARED BY: U.S. ARMY ENGINEER DISTRICT, ST. LOUIS

AUGUST, 1980

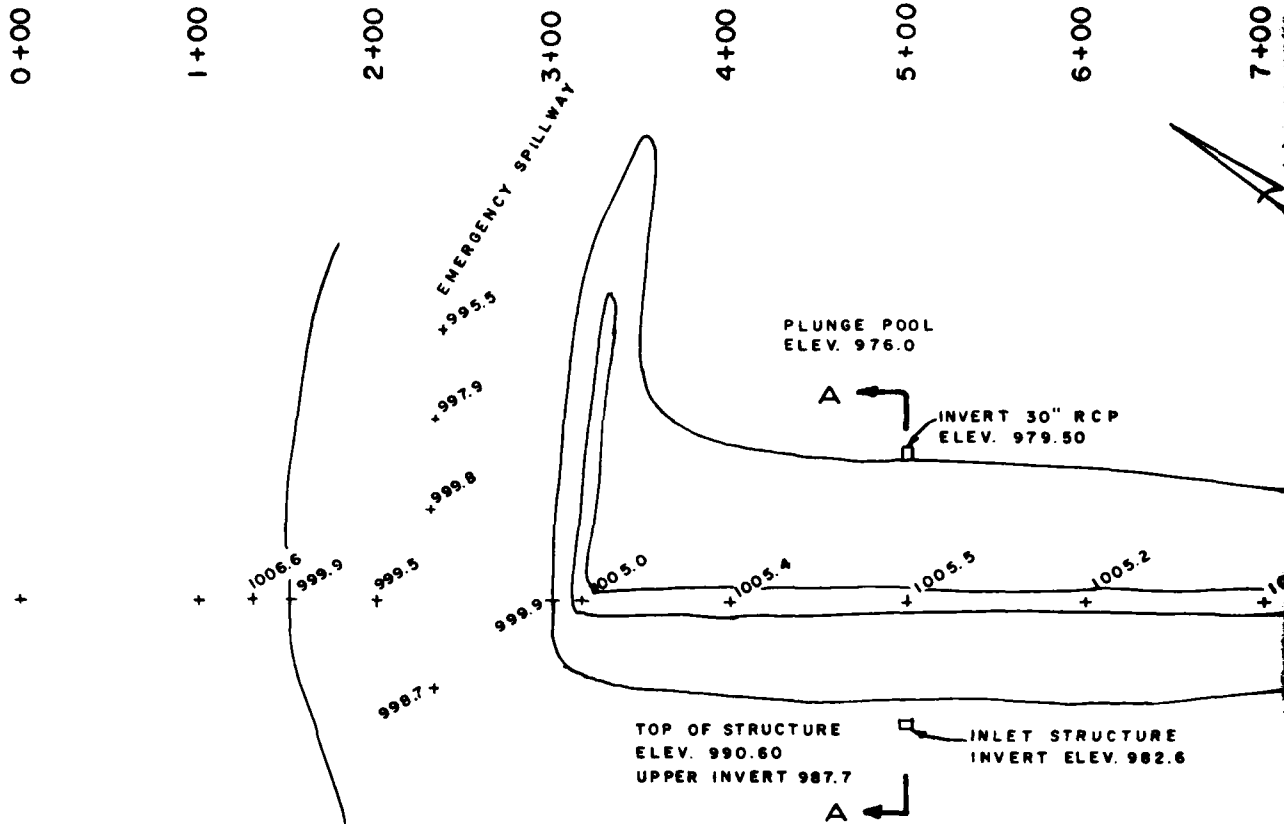
PLAN VIEW

POOL

SCALE: 1" = 100'

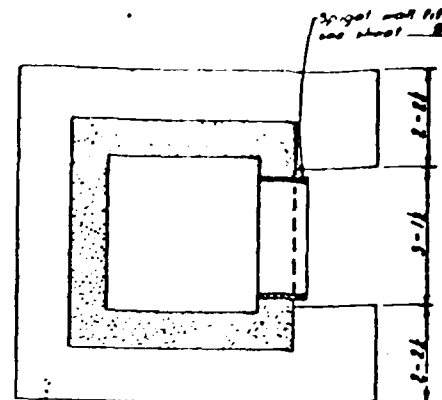
SECTION A-A

- 1 Chamfer all exposed edges $\frac{3}{8}$ "
 2 For Trash Rack details see Sheet 11.

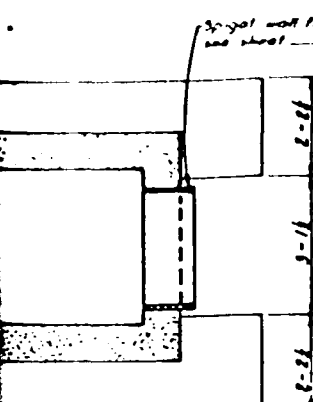
SECTION A-A

Note: Modify cradle shown on sheet 7 as required to fit between riser footing. Cradle and riser footing shall be separated by 1/4" Bituminous Type preformed expansion joint filler.

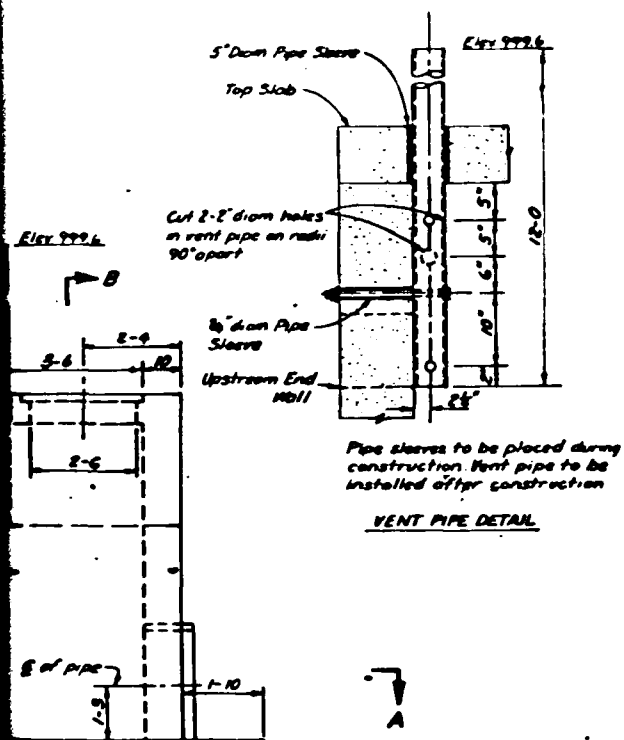
VENT PIPE DETAIL

MATERIAL SCHEDULE - VENT PIPE		
Quantity	Item	Length
1	4" Diam Std Galv Pipe	12'-0"
1	5' Diam Std Galv Pipe Sleeve	0'-8"
3	1/2" Diam Std Galv Pipe Sleeve	0'-10"
3	1/2" Diam Galv Steel Bolts w/ Nut, Lock Washer & 2 Flat Washers	1'-6"

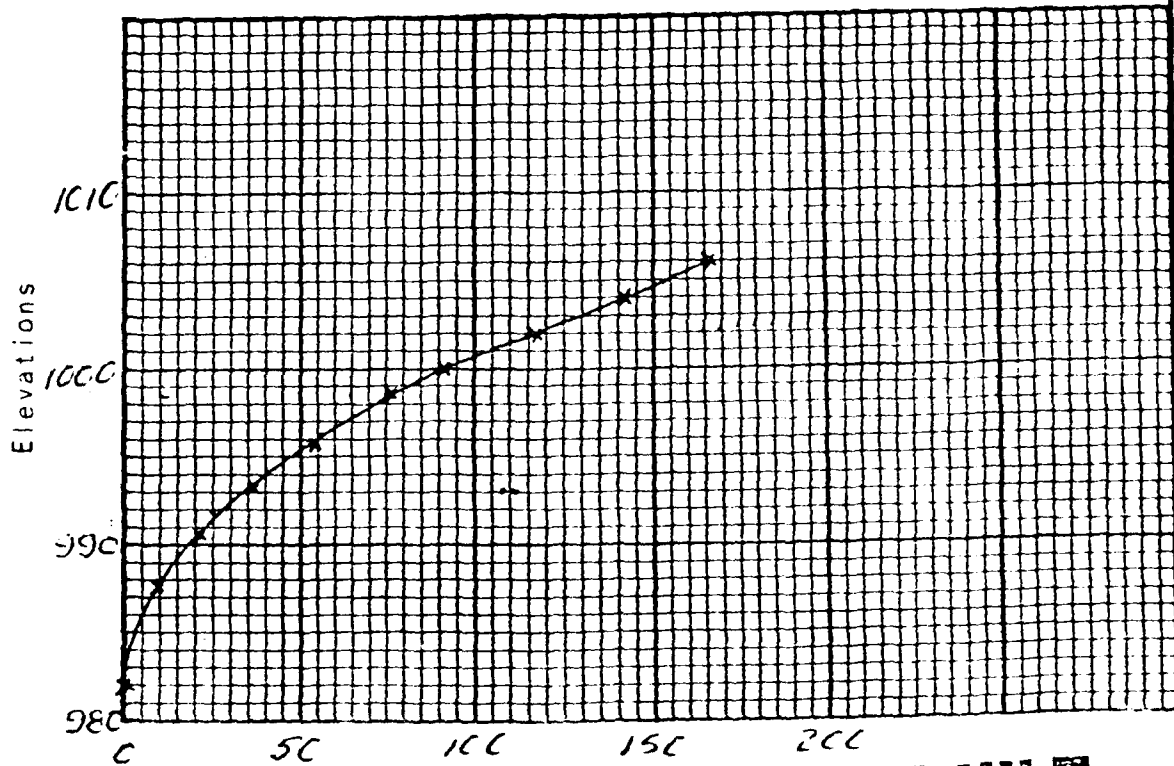
This is a dry dam with an orifice at Elev. 982.6

Maximum Water Surface Elev. 1004.56

Total Storage - Ac.Ft.

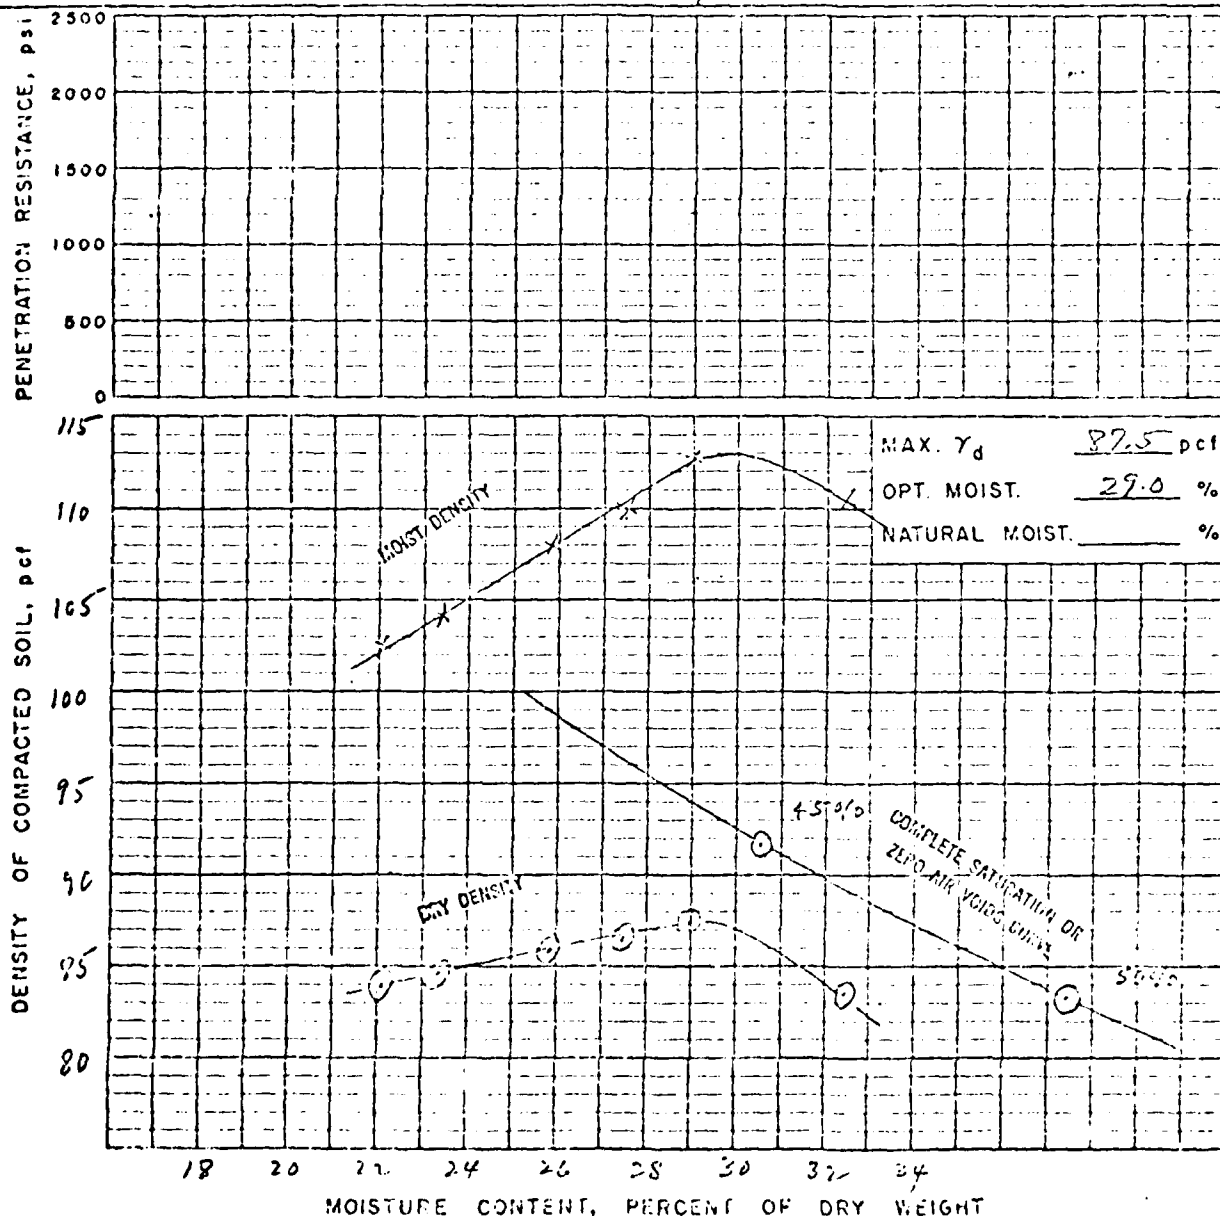
MAX. PARTICLE SIZE INCLUDED IN TEST 2.36 " STD (ASTM D-698) ☒ METHOD C

SPECIFIC GRAVITY (G_s) { MINUS NO. 4 2.67 MOD (ASTM D-1557) ☐ METHOD _____
PLUS NO. 4 _____ OTHER TEST ☐ (SEE REMARKS)

ADJUSTED FOR THE MINUS NO. 4 FRACTION
CRUSHED OF TOTAL SAMPLE

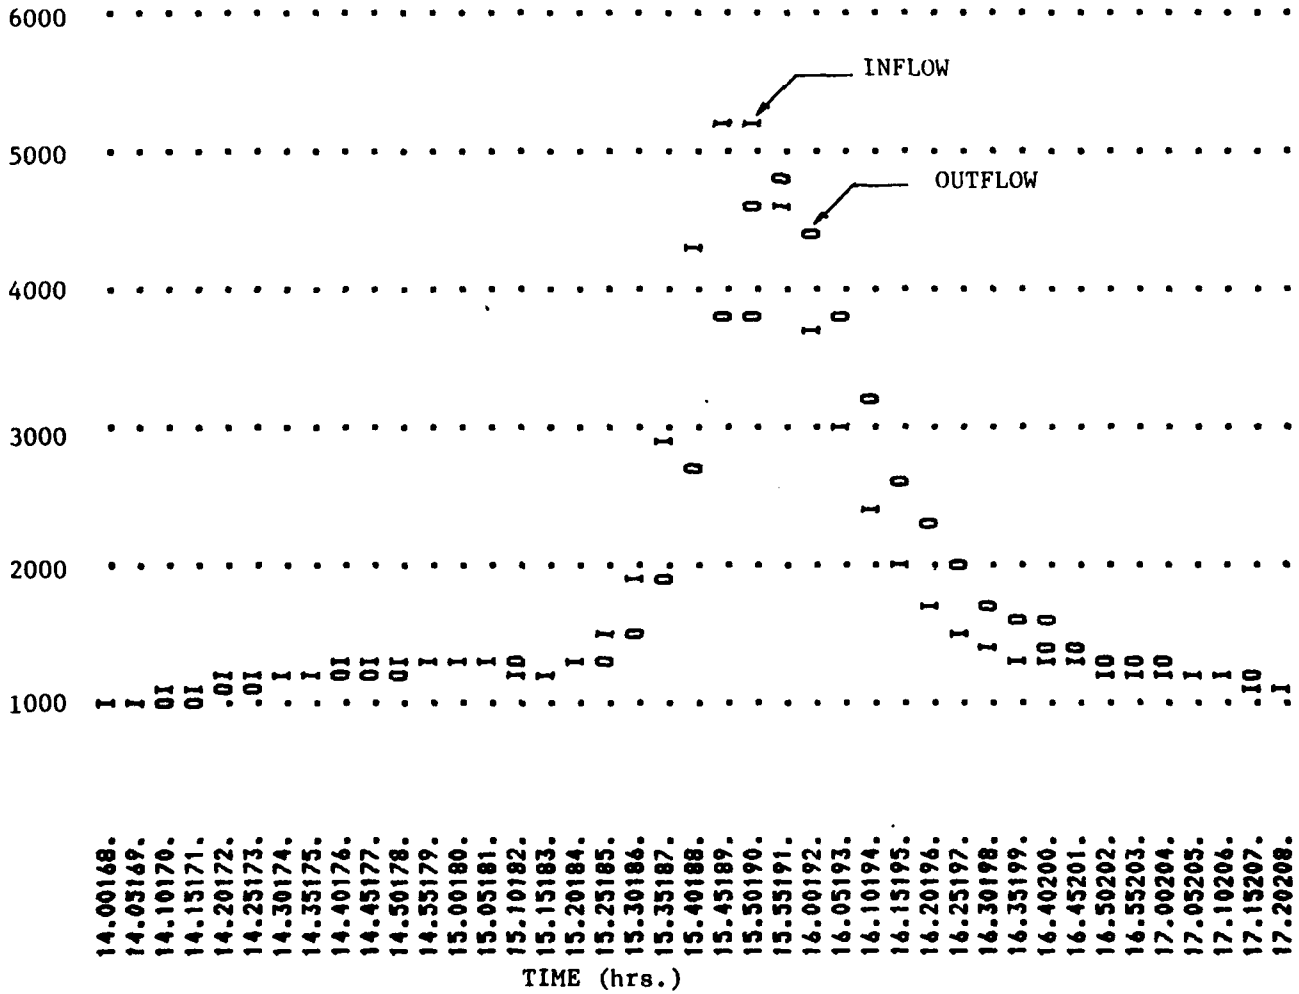
DISCHARGE (c.f.s.)

MAX. INFLOW = 5211 c.f.s.
MAX. OUTFLOW = 4794 c.f.s.

Based on the hydrologic and hydraulic analysis presented in Appendix C, the combined spillways will pass 100 percent of the Probable Maximum Flood. The Probable Maximum Flood is defined as the flood discharge that may be expected from the most severe combination of critical meteorologic and hydrologic conditions that are reasonably possible in the region. The recommended guidelines from the Department of the Army, Office of the Chief of Engineers, require that this structure (small size with high downstream hazard potential) pass 50 percent to 100 percent of the PMF, without overtopping. Considering the height of dam (27 ft), the maximum storage capacity (152 ac-ft), and the lack of any permanent water storage, 100 percent of the PMF has been determined to be the appropriate spillway design flood. The spillways will pass a 1 percent probability flood without overtopping the dam.
